Crookwell 2 Wind Farm

Second Annual Report on the implementation of the Operational Flora and Fauna Management Plan

June 2023
Report No. 8172.05 (30.0)

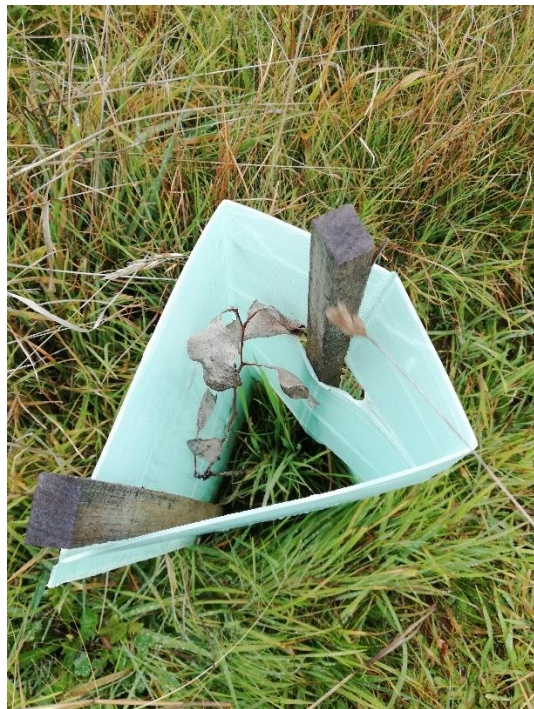
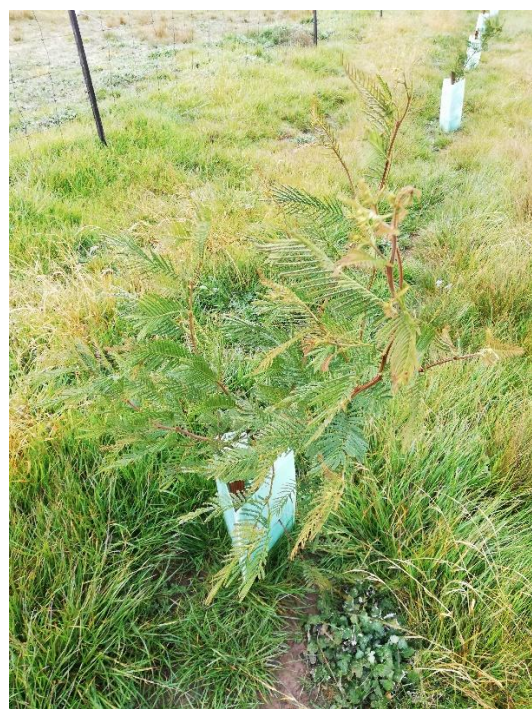
Example of dead *Eucalyptus* sp. (left) and flourishing *Acacia* sp. (right) in PA8

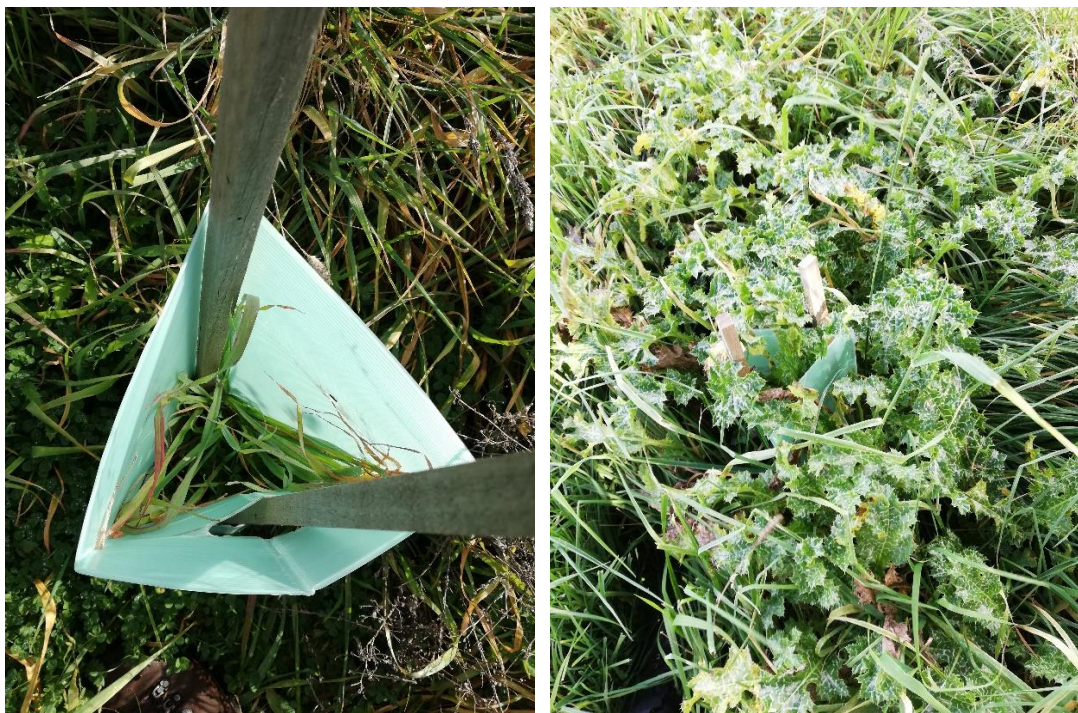
Example of an 'empty' guard (left) and guard infested with Variegated Thistle (right) in CR1

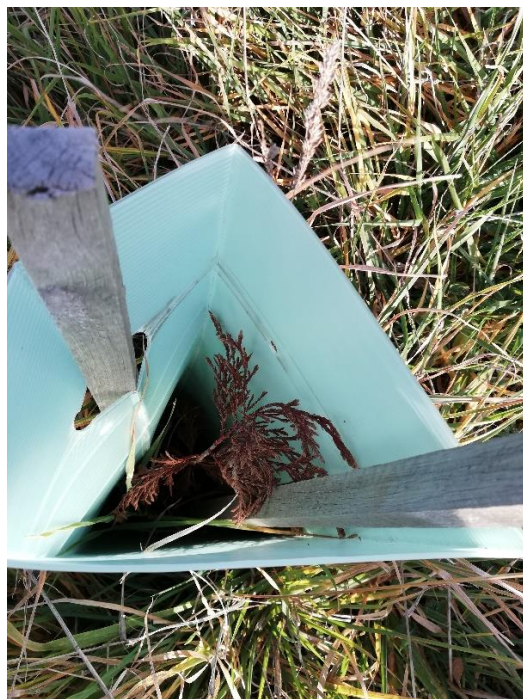
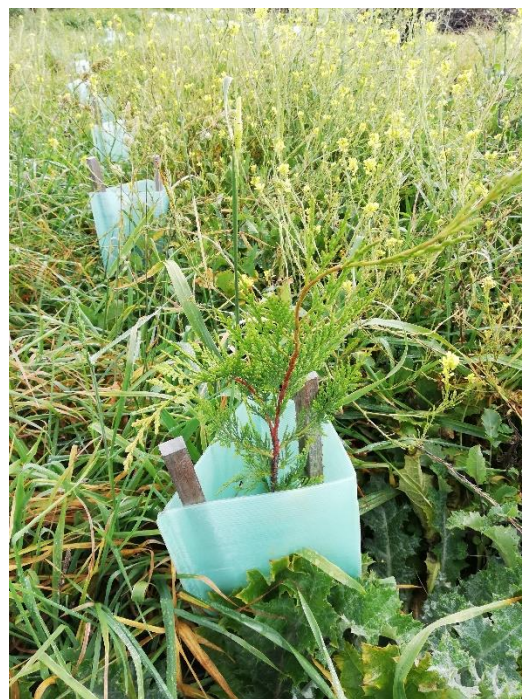
Example of a dead cypress (left) and a live cypress surrounded by weeds (right) in CR4

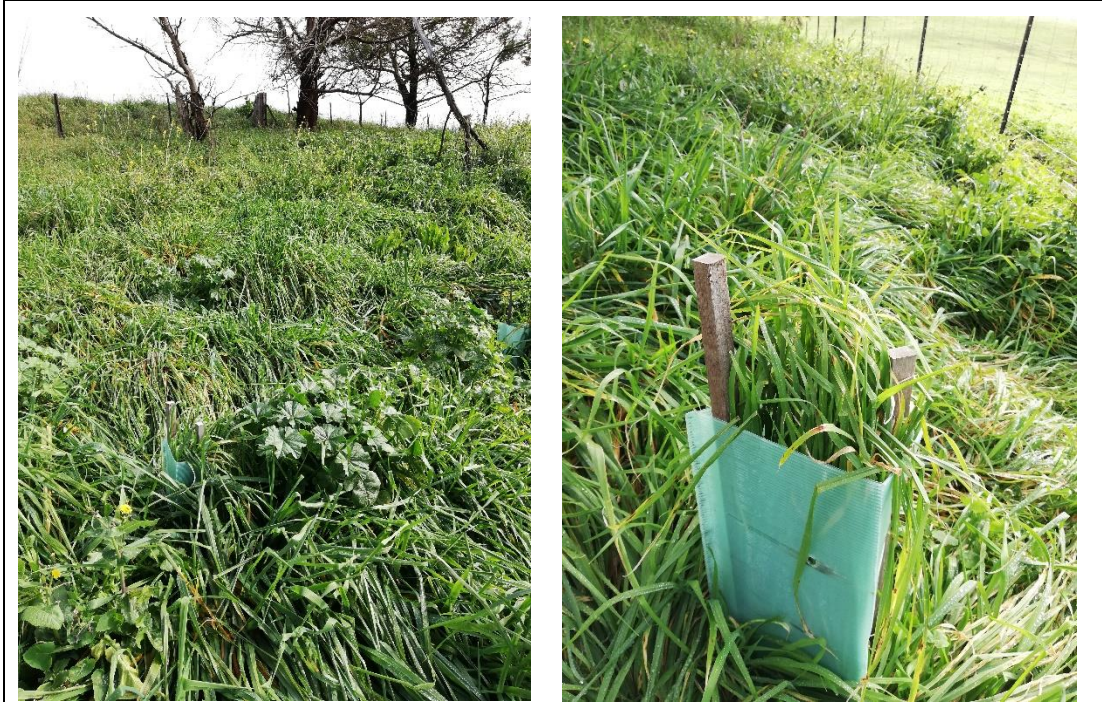
Tree guards overrun by weeds in CR6

- Grassy weeds near plantings be slashed where possible and/or treated with an appropriate herbicide. Care must be taken to avoid impacting live plantings.
- Dead native plants within areas of revegetation be replaced.
- Consultation should be undertaken with local landholders and interest groups on the replacement of *Cupressus x leylandii* with locally indigenous trees.
- A watering regime is implemented within areas of revegetation to increase the chance of plant survival over dry periods of the year.

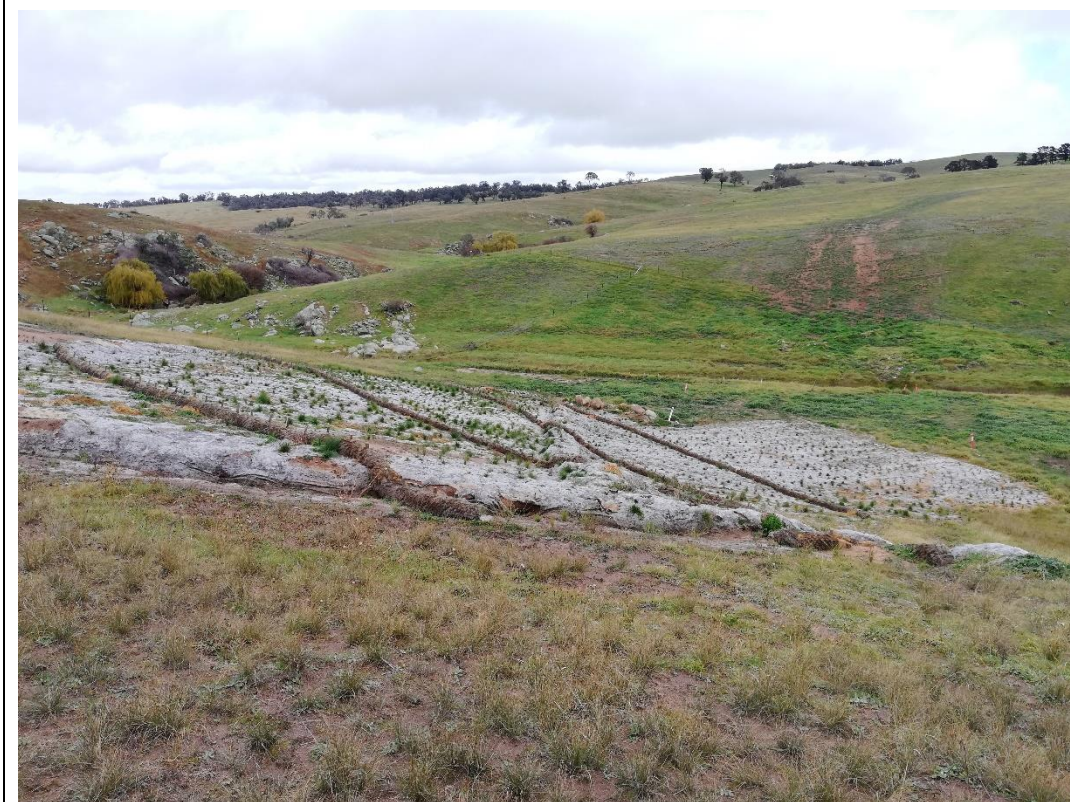
Riparian zone (west of T23) – Photo taken from north (looking south)

- The area was securely fenced on all sides;
- Jute matting had been installed across the entire sloped planting area to manage weeds, and allow for success of plantings;
- Plantings comprised of a range of native grasses including plume grass (*Dichelachne* sp.), red-leg grass (*Bothriochloa* sp.) and Kangaroo Grass (*Themeda triandra*);
- Four coir logs had been installed at regular intervals to manage erosion throughout the planting area;
- At the time of survey, survivorship of planted grasses was estimated to be 90%;
- There was some encroachment of weeds into the area including Clover, Flatweed, Sheep Sorrel and Annual Poa.
