FINAL REPORT

Stormwater Management Plan for the proposed Crookwell II Wind Farm

17 AUGUST 2009

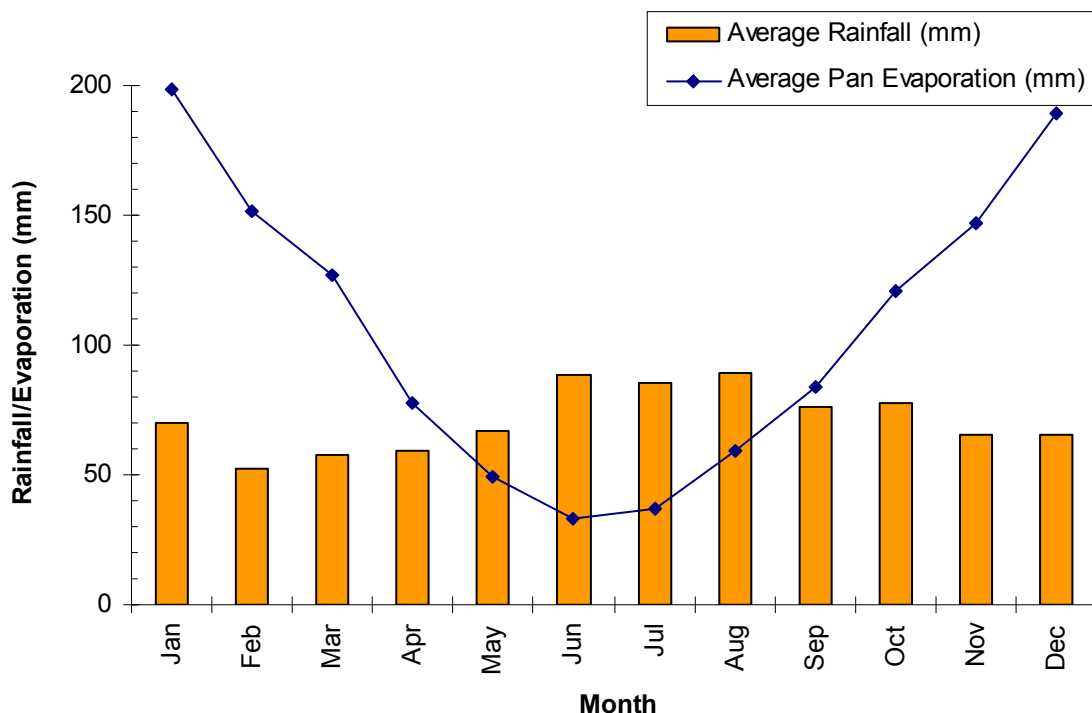
Figure 2-1 Average Monthly Rainfall and Pan Evaporation

A comparison of the average monthly rainfall and pan evaporation is illustrated in Figure 2-1. During summer the average monthly evaporation is considerably higher than the average monthly rainfall.

The average daily pan evaporation over the catchment is approximately 3.5 mm. Average daily pan evaporation shows a distinct summer peak (highest in January) and winter low (lowest in June).
